**IN THE UNITED STATES DISTRICT COURT
FOR THE SOUTHERN DISTRICT OF TEXAS
GALVESTON DIVISION**

No. 3:19-cv-207

**MEMORANDUM OPINION AND ORDER
ENTERING FINDINGS OF FACT AND
CONCLUSIONS OF LAW**

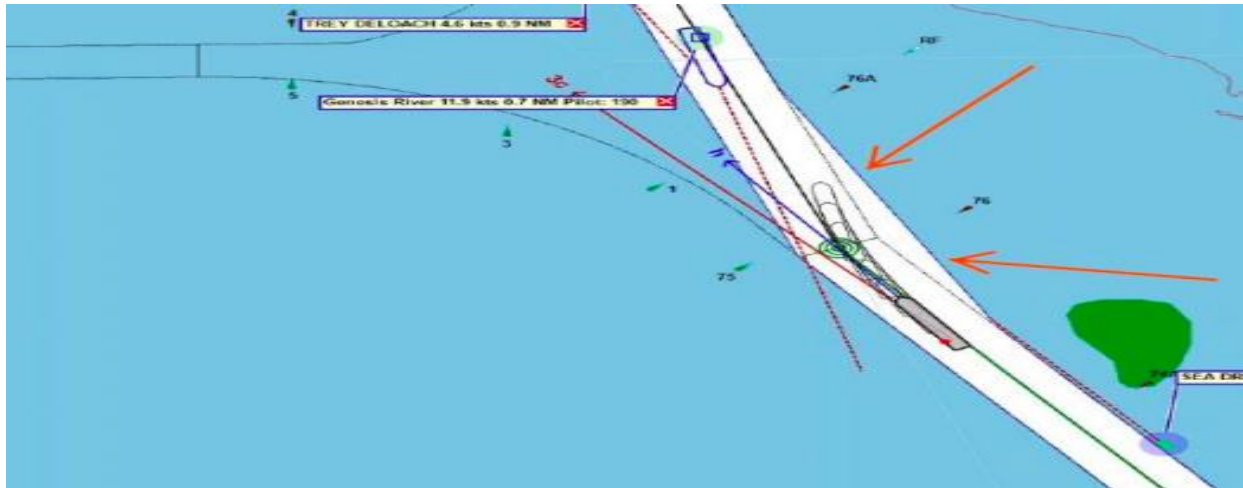
Figure 5. Widener at the Bayport Flare

The Bayport Flare is a highly trafficked area near the intersection of the Houston Ship Channel and the Bayport Channel. To accommodate the high traffic and promote safer meetings between ships in the area, a “widener” has been

dredged at the elbow of the channel, which provides an additional width of suitable water depth for inbound vessels.

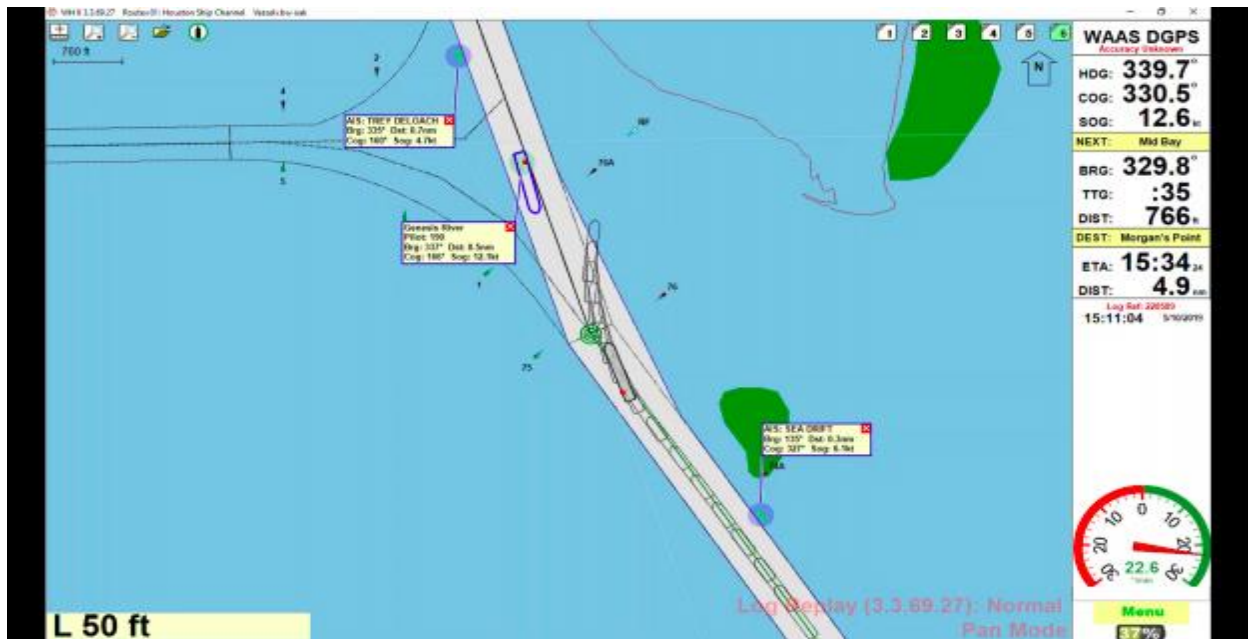
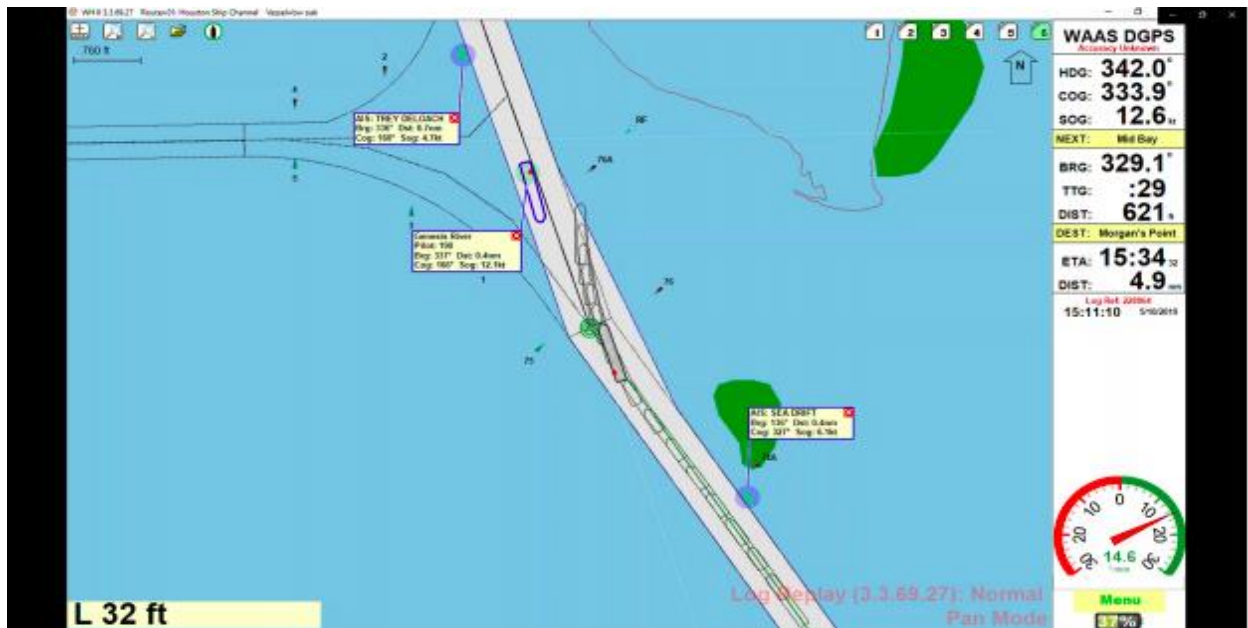
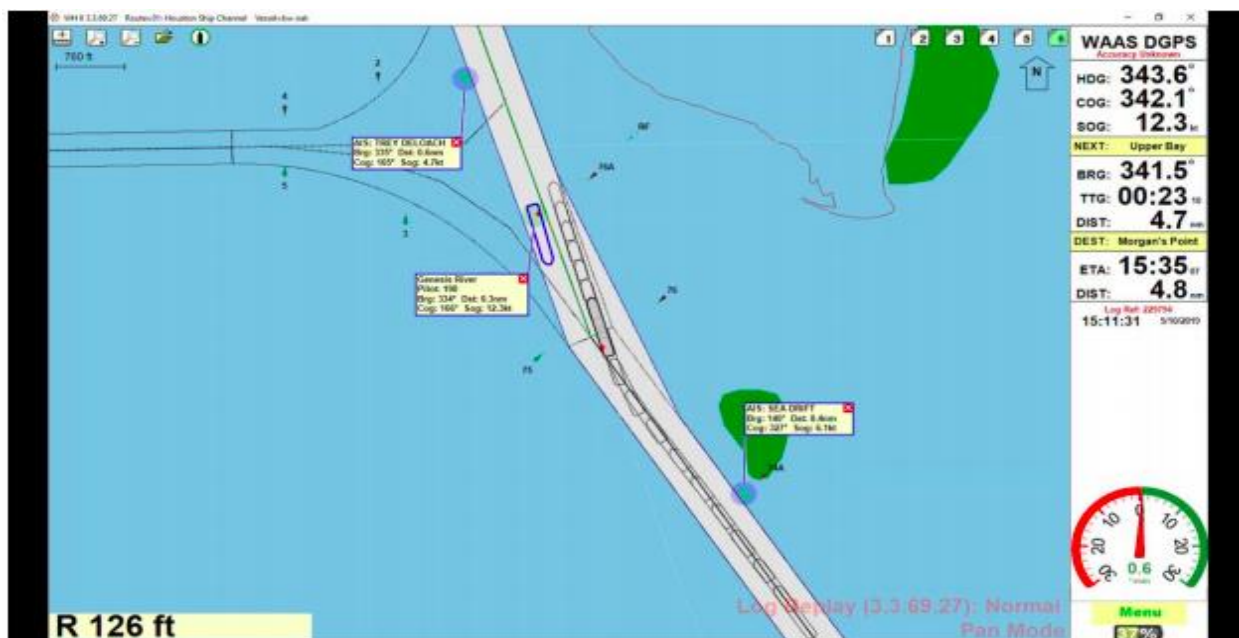
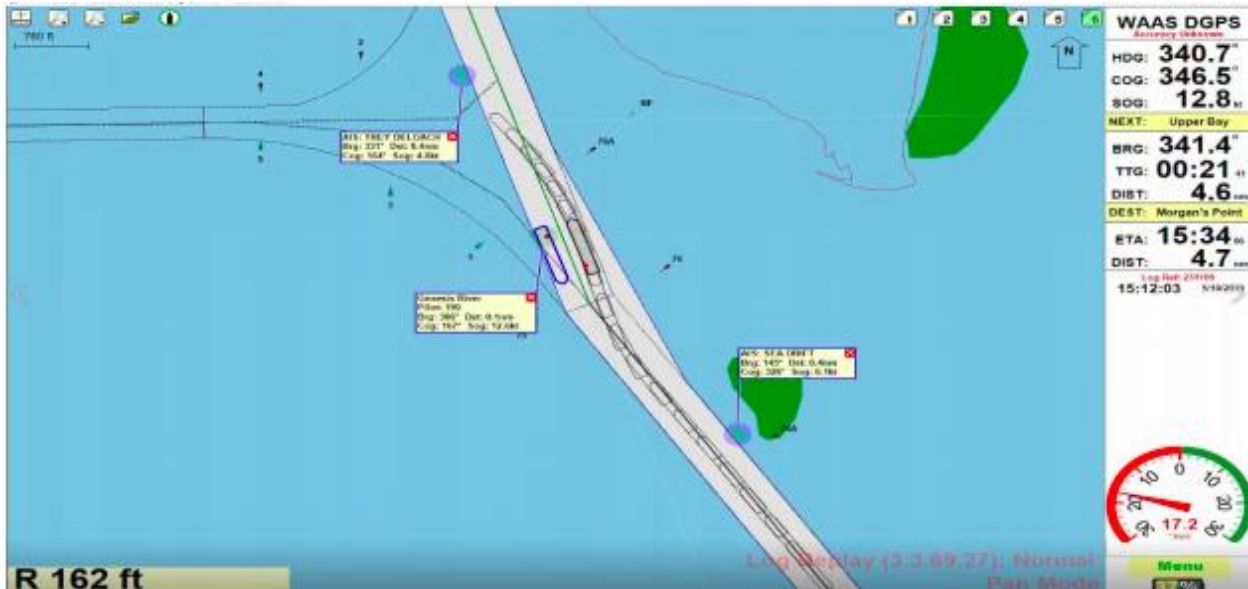
Soon, the swiftly cruising, fully loaded vessel was approaching the *BW Oak* near the Bayport Flare. When the vessels were about a mile apart, they agreed to a port-to-port, one-whistle passing (*i.e.*, a passing in which the vessels stay in their respective right-lane positions). To execute this passing arrangement, they used the “centerline approach,” or “Texas chicken,” which begins with each vessel navigating along the channel’s centerline.³ Then, once they are within about a half mile, each turns to the starboard side to prepare to pass the other. This maneuver facilitates a safe passing because the hydrodynamic forces acting on the vessels as they pass stern to stern help them re-align in the center once the passing is complete.

Around the time the two vessels agreed to this passing, the *BW Oak* was preparing to make a starboard turn at the flare. As she did, her stern swung out slightly to the port side, crossing the centerline by 49 feet.

³ Figures 6–12 illustrate the passing of the *Genesis River* and the *BW Oak*. The ship descending from the top of each illustration is the *Genesis River*; the one moving up from the bottom is the *BW Oak*.

By the time the *Genesis River* and the *BW Oak* closed to within a half mile, the *BW Oak* had completed her turn at the flare. She had then moved 134 feet to the right of the centerline, comfortably on the red side.

In making the turn at the flare, Captain Barton opted against steering the *BW Oak* through the widener on the red side. If he had, Captain Barton testified, the two vessels would have been temporarily pointing directly at each other, an “uncomfortable” heading for them both.

As the vessels passed each other, Captain Charpentier expressed no concern that the *BW Oak* was squeezing the *Genesis River* against the channel bank on her starboard side, did not ask the *BW Oak* for more room, nor ever suggested that the *BW Oak*’s position in the channel otherwise impeded the *Genesis River*’s navigation. In fact, Captain Charpentier has never criticized the *BW Oak*’s handling of the

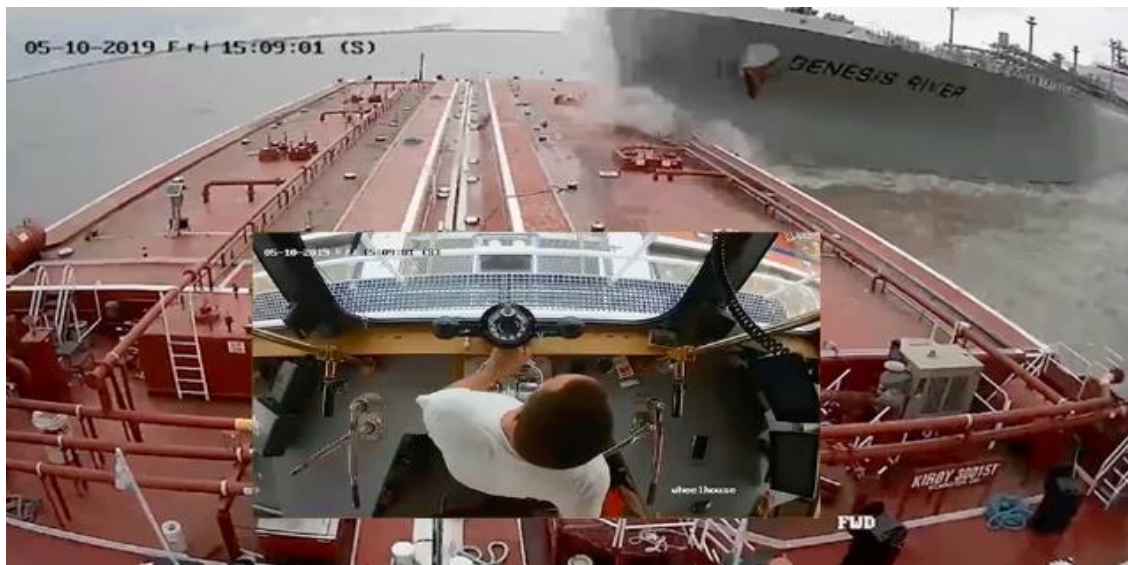
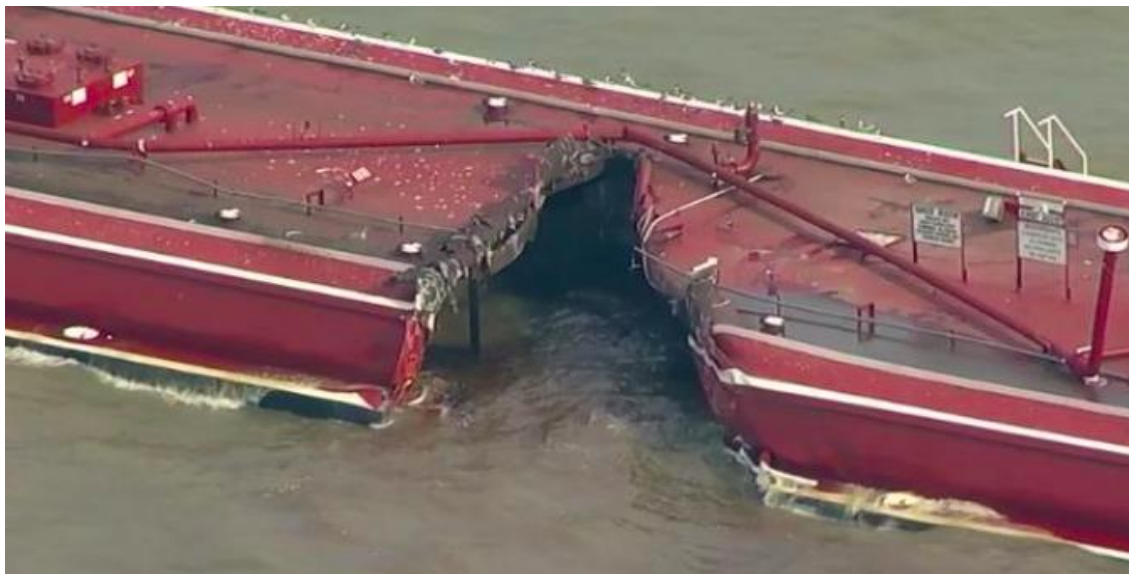
Figure 13.

While Captain Marie tried to move the *Voyager* to the green side, the *Genesis River* crossed the channel's centerline and entered the barge lane where the *Voyager* had been. Had the *Genesis River* maintained this new position on the red side of the channel, she would have complied with the new starboard-to-starboard agreement. But, as Captain Charpentier predicted, she did not. Shortly after she darted to the red side of the channel, the *Genesis River* took yet another sheer, which sent her back toward the green side where the *Voyager* had fled.

Both Captain Marie and Captain Charpentier now realized that a collision was certain. Seconds after the vessels' crews braced for impact, the *Genesis River's* bow sliced into one of the barges (the *Kirby 30015T*), nearly cutting her in half, and reformat gushed into the channel. The force of the impact also caused the other barge (the *MMI 3041*) to capsize. Fortunately, though the damage to the vessels was great and the spill catastrophic, there was no loss of life.
